# **REPUBLIC OF THE MARSHALL ISLANDS**

Maritime Administrator

## **ANNUAL REPORT ON MARINE SAFETY INVESTIGATIONS 2024**

**Published by: Republic of the Marshall Islands Maritime Administrator on 1 July 2025**

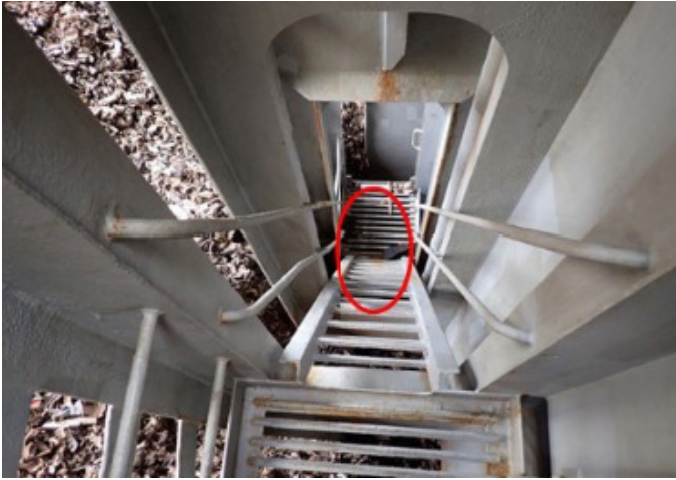
Figure 1: Cargo Hold No.1 aft access ladder. The red circle indicates where the C/E, ETO, and Fitter were located at the bottom of the inclined ladder on the intermediate platform. The cargo of scrap metal is visible in the hold.

An RMI-registered bulk carrier was in laden condition carrying a cargo of scrap metal. The C/E, ETO, and Fitter were conducting maintenance on an electrical junction box on the port side of the cross deck between Cargo Holds Nos. 1 and 2. Prior to the afternoon coffee break, the C/E told the Bosun that he was going to enter Cargo Hold No. 1 to get a welding cable and other tools that had previously been left inside the cargo hold. The Bosun told the C/E that it was dangerous and that he should get permission from the Master before entering. At the end of the working day, the Bosun went on deck with a flashlight to find the C/E, ETO, and Fitter as they had not been seen since the coffee break. The Bosun entered Cargo Hold No.1 without telling the OOW or wearing an SCBA.

While on the vertical ladder leading from the main deck to the upper platform inside Cargo Hold No.1, the Bosun saw the light reflect from the reflective patches on the missing crewmembers' coveralls. The Bosun went back on deck, raised the alarm, and then started removing the cleats from the cargo hold hatch cover. A rescue was conducted per the ship's enclosed space entry rescue plan and the C/E, ETO, and Fitter were removed from Cargo Hold No. 1 without further incident. All three were unresponsive when removed from the cargo hold and did not respond to CPR. The C/E, ETO, and Fitter were subsequently determined to be deceased.

- Entering a loaded cargo hold without authorization and without following established shipboard enclosed space entry and rescue procedures is extremely hazardous and should not be attempted.
- Physical boundaries are critical for preventing unauthorized access into an enclosed space.
- Enclosed space rescue procedures must be properly practiced and drills conducted as if they were a real emergency.
- Stop-work authority can prevent marine casualties. For stop-work authority to be effective, crewmembers must not only be aware that they have this authority, but they must also have confidence that the authority is non-negotiable and can be exercised without fear of repercussion. They must also be as familiar with how to issue and respond to a stop-work action or instruction as they are with their other shipboard duties.

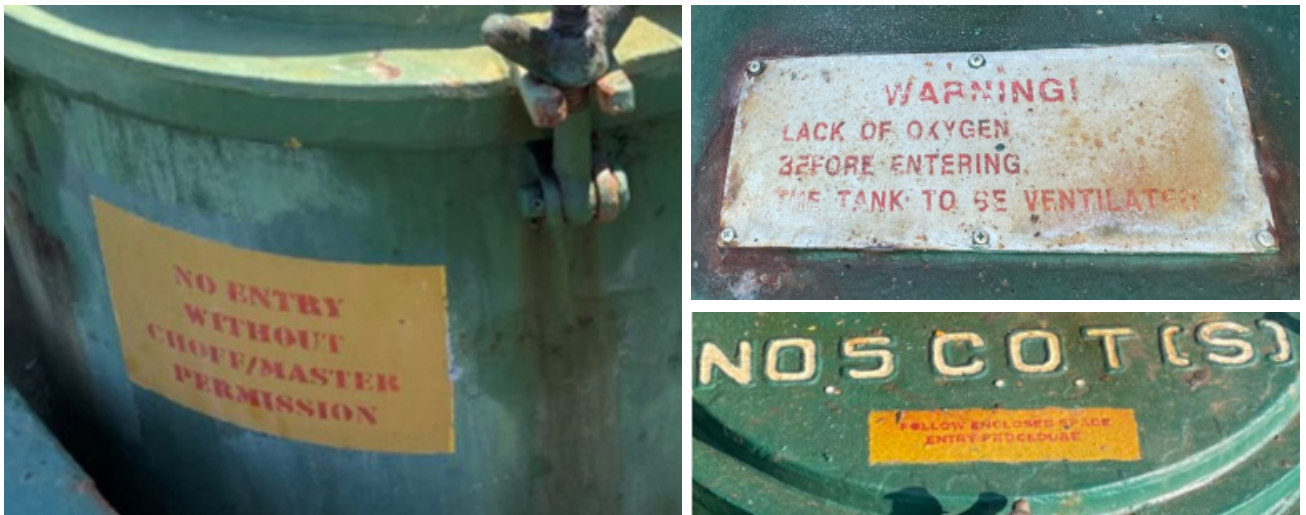
Figure 2: COT No. 5S tank access hatch cover warning signage.

The Administrator's marine safety investigation determined that unauthorized entry into an enclosed space was an unsafe act which could have been influenced by a state of hypoxia. The following lessons learned were identified:

- The Company documented control measures existed but were not followed on board. This resulted in inadequate hazard identification of the risk of exposure to  $N_2$  and the danger of an  $O_2$  deficient environment. The stop-work authority procedure was not robustly implemented and therefore did not prevent unauthorized access to an enclosed space.

- Necessary implementation and adherence to procedures combined with adequate oversight of maintenance and working routines should be sufficient in ensuring the safety of crewmembers undertaking the task required of them.

- The stop-work authority, if exercised by crewmembers, is designed to identify and stop an unsafe act or unsafe condition. Enclosed Space Rescue procedures must be properly practiced and drilled as if it were a real emergency. If crewmembers are not familiar with Enclosed Space Rescue procedures, they stand to put themselves and their fellow crewmembers in danger.

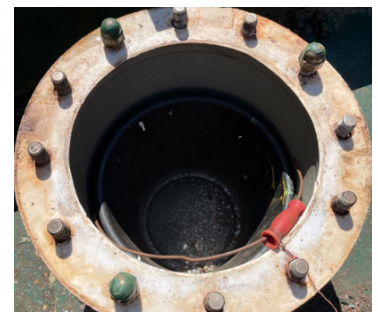
Figure 3: COT No. 5S Butterworth hatch with plastic bucket located inside.

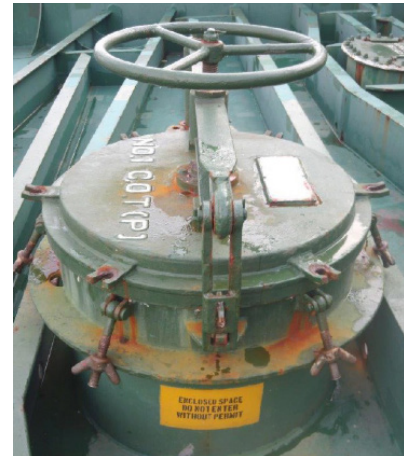
The Administrator's marine safety investigation determined that the C/O entered a COT despite his knowledge that it had been inerted with nitrogen and had not been ventilated. The C/O entered the COT without complying with the enclosed space entry procedures that were contained in the Company's SMS. The C/O disregarded the Deck Cadet when he intervened and asked him to check the atmosphere inside the COT with a portable gas detector. The intervention of the Deck Cadet may have been more effective if he had expressly exercised his stop-work authority. The stop-work policy in the Company's SMS was not followed. The crewmembers stated that despite being aware of their stop-work authority, they were not confident in exercising this authority. The following lessons learned were identified:

Figure 4: COT No. 1P access hatch showing warning label "Enclosed Space Do Not Enter Without Permit."

- Any entry into an enclosed space without taking proper precautions and without complying with the enclosed space entry procedures contained within the Company's SMS is hazardous and can be fatal.
- Risk assessments and Toolbox Talks must identify and include all associated hazards related to the conduct of work in and around an inerted COT.
- For stop-work authority to be effective, seafarers must not only be aware that they have the authority to intervene to stop an unsafe act or condition, but they must also be confident that they can exercise this authority.

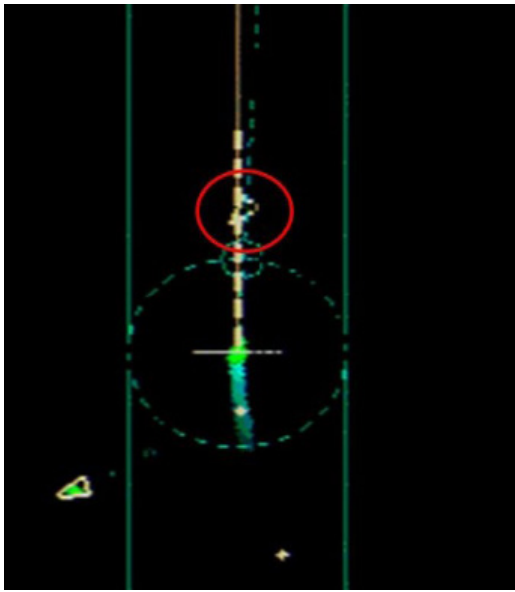
In the early morning hours, an RMI-registered bulk carrier collided while in a crossing situation with a fishing vessel. The bulk carrier was the give-way vessel and the fishing vessel, which was not engaged in fishing, was the stand-on vessel. The OOW on the bulk carrier was alone on watch. A designated Lookout had not been posted so that the deck ratings would be fully rested before undertaking deck duty later that morning. The fishing vessel's Master was on watch assisted by a Mate in maintaining a proper lookout.

Figure 5: Fishing vessel AIS contact circled in red acquired on ARPA three minutes before the collision.

The collision occurred soon after the fishing vessel turned toward the bulk carrier when the fishing vessel was less than 0.7 NM off the bulk carrier's starboard bow. At the time, the bulk carrier's OOW was using the autopilot to turn the ship to starboard. Approximately three hours after the collision, the fishing vessel sank. All six of the crewmembers who had been on board were rescued by another fishing vessel in the vicinity. The bulk carrier's OOW did not inform the ship's Master of the collision or assist in the recovery and rescue of the crewmembers from the fishing vessel and continued on the ship's planned voyage.

- Autopilot should not be used when large alterations of course are required to resolve a developing situation with another vessel. An additional watchstander should be called to the Bridge in ample time so that the changeover from autopilot to manual steering can be made before a close quarters situation exists and so that the continuity of the lookout is not broken.

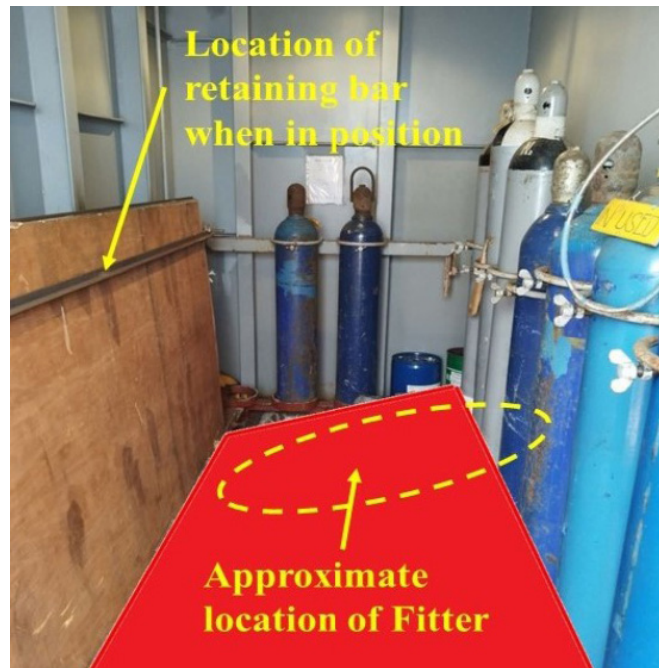
A C/E on board an RMI-registered bulk carrier found the Fitter pinned under steel plates that were stored vertically on a rack in the Oxygen Bottle Room. The steel plates, which each weighed approximately 294 kg, had fallen and were lying on top of the Fitter's legs and chest so that his body was wedged in a semi-reclined position with his lower body and back on the deck. Only the Fitter's head, which was pressed against two of the O<sub>2</sub> bottles, was visible. The retaining bar used to secure the steel plates was pressed against the Fitter's neck. Crewmembers responded immediately to the C/E's call for assistance and lifted the steel plates off the Fitter, who was not breathing. The crewmembers transported him by stretcher to the Ship's Office where they started to administer CPR. The crewmembers administered CPR

for approximately an hour, but the Fitter remained unresponsive and was determined to be deceased. The Administrator's marine safety investigation was not able to determine with certainty what caused the steel plates to fall and likely knock the Fitter down, who had been alone in the Oxygen Bottle Room. It was determined that the retaining bar used to secure the steel plates had possibly been removed by the Fitter sometime before they fell and pinned him against the O<sub>2</sub> bottles.

Additionally, the investigation determined that although the location and design of the storage rack was effective for storing steel plates securely when the retaining bar was in place, a potential hazard exists whereby the steel plates may fall whenever the retaining bar is removed or fails for any reason. The following lessons learned were identified:

Figure 6: The approximate position of the steel plates and location of the Fitter when he was found by the C/E.

- The Company's safe work procedures and the C/E's and 2/E's instructions were not followed. This created a situation where whatever work the Fitter may have intended to do in the Oxygen Bottle Room was not subject to being reviewed with either the C/E or 2/E. Such review is an opportunity to ensure the task is planned, the associated risks identified, and appropriate control measures put in place so that it can be completed safely. It also created a situation where no one on board knew where the Fitter was.
- Handling unsecured steel plates, even when they are on a storage rack, is a potentially dangerous activity and should not be attempted without assistance.
- The location and design of storage racks should eliminate or reduce the potential for steel plates to fall while being handled.
- The importance of maintaining positive control of keys for spaces with restricted access.

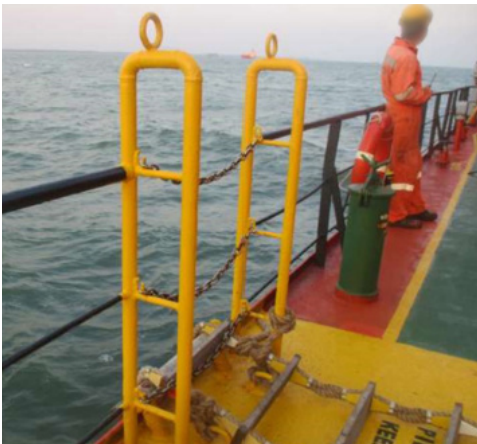
Figure 7: Starboard side pilot boarding area.

An RMI-registered gas carrier was underway at a speed of 8 kn in squally weather. The 3/O and ASD welcomed the Pilot on board at the pilot boarding area and, after completing the boarding procedures, the 3/O began to escort the Pilot to the Bridge. When leaving the boarding area, the 3/O and the Pilot heard a scream and shouting for help. They then realized that the ASD had fallen overboard. The 3/O ran aft to throw a lifebuoy to the ASD and meanwhile alerted the Master on the Bridge by means of his hand-held radio. The ASD, who was not wearing a life jacket, was not able to reach the lifebuoy. The pilot boat became aware of the situation and approached the ASD in the water. A crewmember on board the pilot boat grabbed a lifebuoy with light

The Administrator's marine safety investigation determined that the ASD most probably fell overboard while securing the rail chains of the pilot access point. The investigation was not able to determine the cause of the ASD's death. The following lessons learned identified that:

- The decision to enact a rescue attempt without proper equipment or training carries a high degree of risk and using rescue cradles or similar equipment can help to successfully recover persons from the water.
- The importance of proper oversight of crewmembers while working on deck and during seamanship evolutions.
- Suitable PPE should be worn when the risk of falling overboard exists.

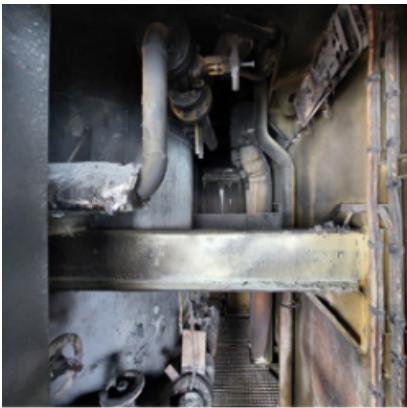
The thermal oil heating system connected to the main engine remained operational while the C/E attempted to rectify the leaking blind flange. This deviation from PMS procedures resulted in the eventual fire. The firefighting effort conducted by the attending crewmembers was unplanned. The immediate actions of the crewmembers fighting the fire with portable fire extinguishers was effective and the fire was extinguished. However, shipboard firefighting procedures were not followed, resulting in increased risk in the event the fire could not be contained and extinguished.

*Figure 8: Starboard Engine Room Casing and Economizer post fire.*

The Administrator's marine safety investigation determined that the cause of the fire, which originated within the starboard Engine Room Casing on the upper deck, was determined to have been started by leaking thermal oil from the blind flange which ignited on an adjacent hot surface. The Administrator's marine safety investigation also determined that procedures for rectifying the thermal oil leak on the blind flange were not followed as they require the main engine to be shut down in order for the thermal oil system to be secured and cooled down. The following lessons learned identified:

- The importance of adhering to documented maintenance procedures and avoid deviating from those procedures especially when conducting unplanned defect rectification.
- The importance of ensuring that adequate thermal insulation is maintained especially in vicinity of flammable fluids and gases. Regular testing and assessment must be conducted to verify adequacy of thermal insulation within machinery spaces and adjacent compartments.
- The importance of regular firefighting drills to ensure crewmembers are familiar with firefighting techniques and practices and the use of firefighting protective equipment.
