AZOV CONFIDENCE MARINE SAFETY INVESTIGATION REPORT

Fatal Engine Room Casing Fire

Black Sea | 2 November 2022

IMO Number: 9372602

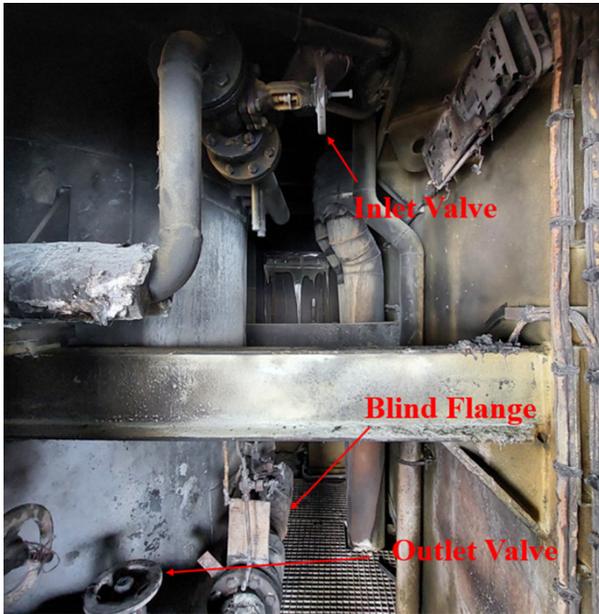
Figure 4: Thermal oil inlet and outlet valves.

The inlet and outlet valves located on the Thermal Oil System (*see Figure 4*) control the flow by obstructing the thermal oil. To stop the flow of thermal oil from entering the Economizer, the inlet valve should be closed, and the outlet valve should be opened. Residual thermal oil may remain within the thermal oil system when the inlet valve is closed and the outlet valve is open.

Upon entering the starboard Engine Room Casing via the Aft Mooring Deck access, the C/E identified that the source of the oil was coming from the thermal oil blind flange (see Figure 7). He proceeded to secure the source of the thermal oil by closing the inlet valve on the thermal oil system and opening the outlet valve (see Figure 4), restricting the flow of thermal oil to the Economizer.

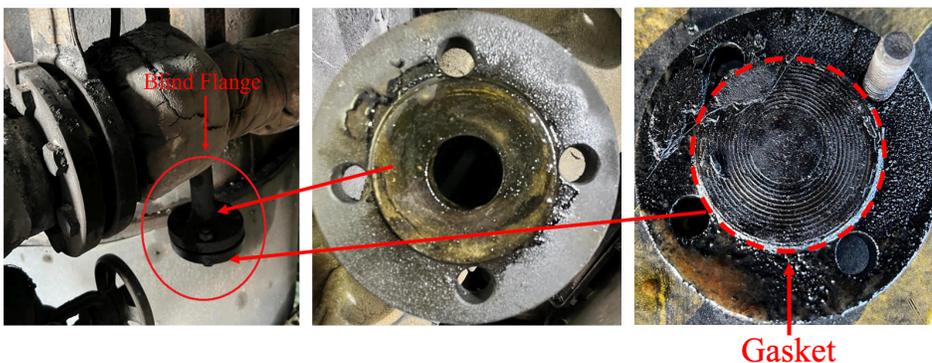
Figure 5: Blind flange components.

The blind flange (*see Figure 5*) contains a gasket which provides a mechanical seal preventing unauthorized release of thermal oil. The thermal oil pressure transmitter measures the pressure of the circulating thermal oil. If the pressure is outside of operating parameters, the pressure transmitter will indicate on the thermal oil alarm panel located in the Engine Control Room (*see Figure 6*).

The blind flange gasket (see Figure 5) was constructed from high purity natural flake graphite. It is commonly used as a basic material for manufacturing gaskets for use in the marine industry. The data sheet supplied by the manufacturer stipulated that the service limitation of the graphite sheet should not exceed less than -200°C or greater than $+3000^{\circ}\text{C}$ at a maximum pressure of 30 bar. The standard operating temperature and pressure of the thermal oil circulated through the Economizer is 180°C and between 1-6 bar. There is no indication that the thermal oil exceeded these parameters on 2 November 2022.

The service life of the blind flange gasket is not documented within the manufacturer's data sheet. The manufacturer's data sheet does not provide recommendations or stipulations for replacement and states that the graphite sheet "can serve for a long time even under harsh working conditions and a very low maintenance cost."

The C/E commenced manipulating the threaded nut arrangement on the blind flange (see Figure 5) to stop the thermal oil leak.

The integrity of the thermal oil blind flange gasket likely failed following adjustment to the securing bolts of the base plate of the blind flange. The gap created during the tightening of the base plate likely resulted in the residual thermal oil escaping through the damaged gasket and igniting on an adjacent hot surface. There is no evidence to suggest that the gasket of the blind flange failed prior to the release of thermal oil.

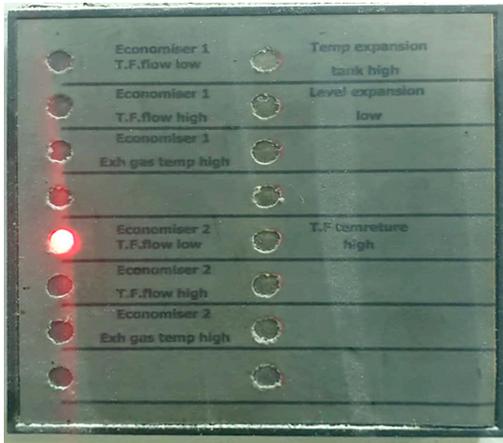
Figure 6: Low pressure alarm (illuminated) for the starboard Economizer.

Shortly after 2000, the C/E was conducting rounds within the Engine Room and noticed oil on the deck plates directly beneath the starboard Engine Room Casing compartment above. The C/E checked the Thermal Oil Heating System Alarm panel located in the Engine Control Room which indicated a low pressure alarm on the starboard Economizer (see Figure 6).

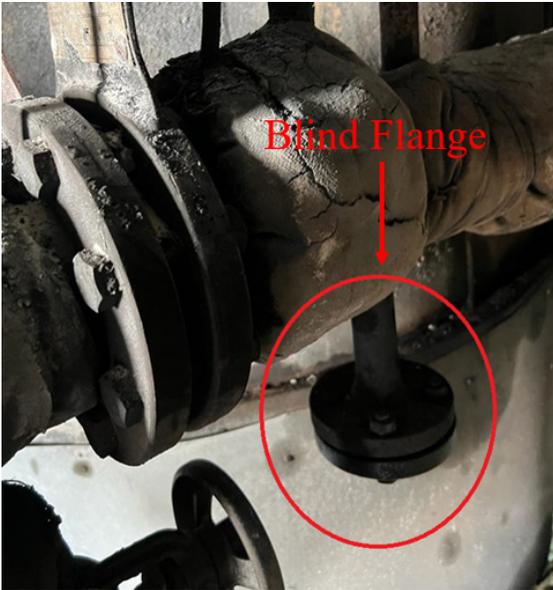
Figure 7: Blind flange location.

The pressure and temperature within the thermal oil system increased due to the closed position of the inlet valve and open position of the outlet valve. The increase in pressure and temperature resulted in pressurized thermal oil escaping the blind flange, filling the starboard Engine Room Casing with atomized thermal oil.

A damage assessment conducted within the starboard Engine Room Casing compartment determined that the source of the fire was in the immediate vicinity of the thermal oil blind flange located on the thermal oil system. The smoke and heat patterns observed surrounding the blind flange indicated that the fire was at its most intense in this area. Less damage was observed in the surrounding area as distance from the source increased.

The cause of the fire, which originated within the starboard Engine Room Casing on the upper deck, was determined to have originated from leaking thermal oil from the blind flange which ignited on an adjacent hot surface.

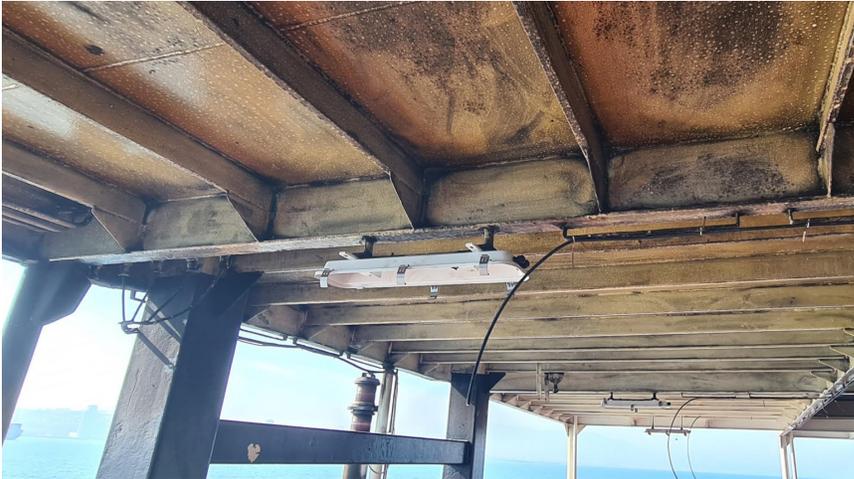
Figure 10: Aft Mooring Deck bulkhead.

Smoke and heat damage to the surrounding area outside the starboard Engine Room Casing was present. Carbon deposits were visible up to approximately 10 m from the entrance to the starboard Engine Room Casing. Fire damage decreased with distance from the origin of the fire within the starboard Engine Room Casing (see Figure 10).

All material damage was confined to the starboard Engine Room Casing and Aft Mooring Deck with no additional damage to other decks or adjacent compartments.

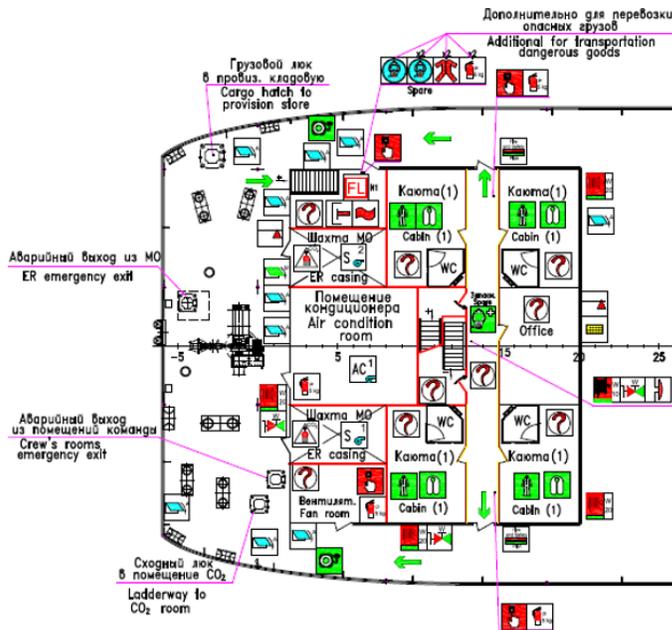
Figure 11: Fire control plan for AZOV CONFIDENCE's upper deck.

AZOV CONFIDENCE's fire control plan was approved by Bureau Veritas and details the fire protection arrangements provided on board (see Figure 11).

The internal bulkheads surrounding the starboard Engine Room Casing were “A-60” class divisions.⁶ The aft bulkhead and hinged door separating the external Aft Mooring Deck and the starboard Engine Room Casing is a “C” class division.⁷

Within the starboard Engine Room Casing compartment was located a remote CO₂ release station and supply ventilator. On the external bulkhead outside the compartment was a fire hydrant and a 20 m water fire hose and nozzle.

A fixed fire detection and fire alarm system was installed in accordance with SOLAS II-2, regulation 7. One smoke detector was located within the starboard Engine Room Casing on the ship’s main deck and a further smoke detector was located within the Engine Room. One heat detector was located within the Engine Room and starboard Engine Room Casing respectively. The fire alarm system provides audible and visual warnings throughout the upper deck when the fire detection system is activated.
