### GREEN FUTURE MARINE SAFETY INVESTIGATION REPORT

Fatal Fall From Height

Kii Suido, Japan | 20 August 2024

IMO Number: 9889631

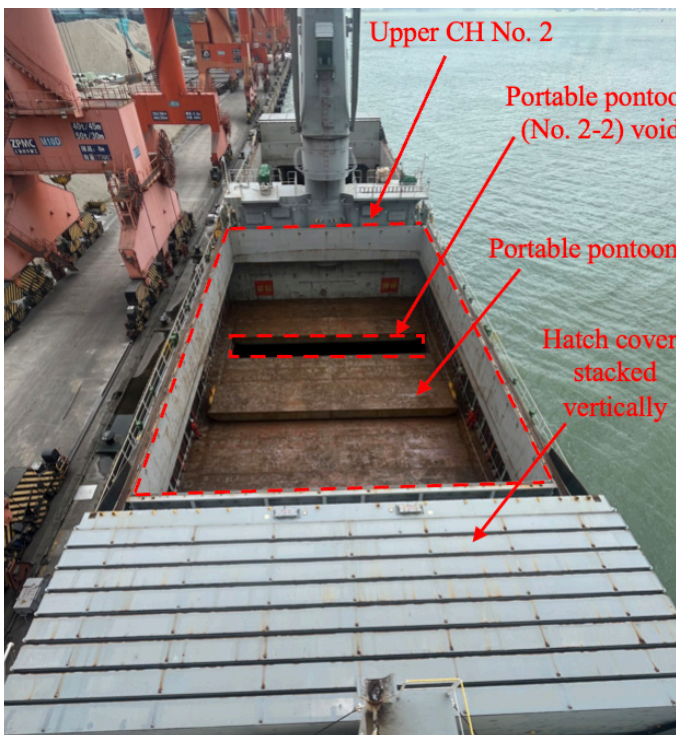
Figure 4: Upper CH No. 2 and vertically stacked hatch covers aft. Portable pontoon No. 2-2 as pictured was located in place (i.e., no void) at the time of the accident.

The height between the top of the pontoon to the tank top within CH No. 2 was 7.8 m.

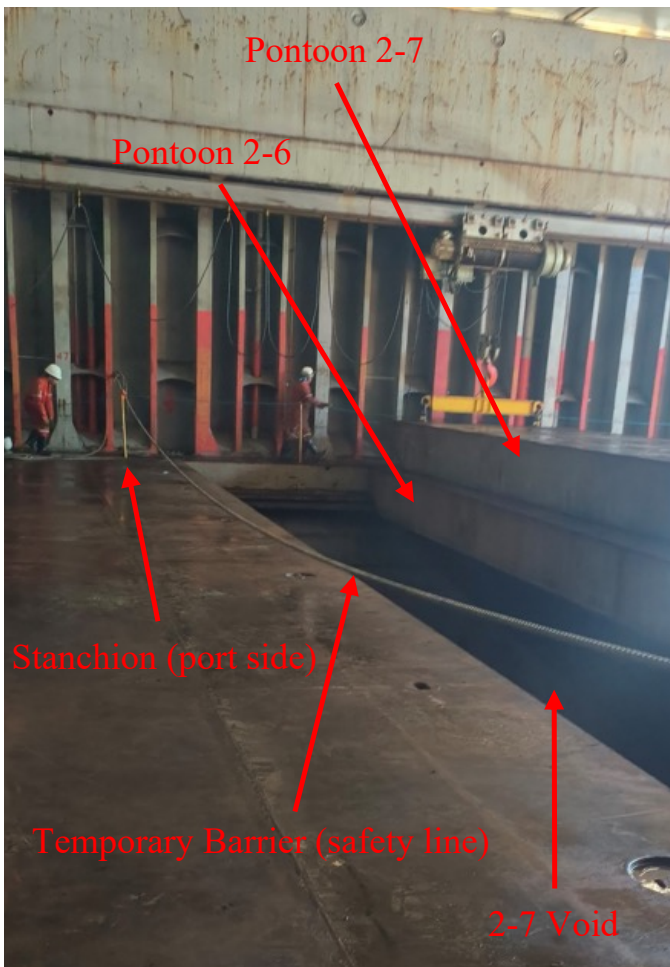
At 0900, the C/O completed the Permit to Work<sup>11</sup> and proceeded to the cargo holds to check on progress. Upon arrival, the hatch covers to CH Nos. 1 and 2 had been partially opened to allow for ventilation and illumination. At approximately 1000, pontoon 2-7 was hoisted from the pontoon deck and placed on top of portable pontoon 2-6 forward. At the same time, the Bosun, OS1, and ASD2 rigged a temporary safety barrier between two vertical stanchions located on the port and starboard side on the pontoon deck to provide a temporary barrier between pontoon 2-8 and the void located where pontoon 2-7 had been removed (*see Figure 5*).

*Figure 5: Pontoon 2-8 and void (2-7) with pontoon 2-7 positioned on top of pontoon 2-6. Temporary safety barrier connected to a stanchion on the port side within upper CH No. 2 and positioned athwartship between pontoon 2-8 and pontoon void 2-7.*

The crewmembers did not recognize that the temporary safety barrier rigged was inadequate. The SMS did not contain specific guidance on stop-work authority, however the crewmembers indicated that they were familiar and aware of the

- (c) risk normalization through the continuous application of an inadequate temporary safety barrier deemed sufficient for the intended work activity without taking into account the hazard associated with working at height.

- (i) an alternative method to clean the holds without working in proximity of open pontoons and temporary safety barriers;
    - (ii) requirements and specifications for the securing of a temporary safety barrier to remove the hazard associated with falling within CH No. 2;

1. Required crewmembers to set up strong and tensioned barricades using wire rope and turnbuckles rather than rope.
2. Ensured that PPE is worn properly during cargo hold cleaning operations. For crewmembers who wear glasses, required the use of safety goggles that can be worn over glasses.
3. Reminded all crewmembers to conduct Toolbox Talk meetings and raise any risks for the job during the Toolbox Talk meeting.
