### JABAL HAFIT MARINE SAFETY INVESTIGATION REPORT

Collision with Fishing Vessel

Arabian Sea | 4 March 2025

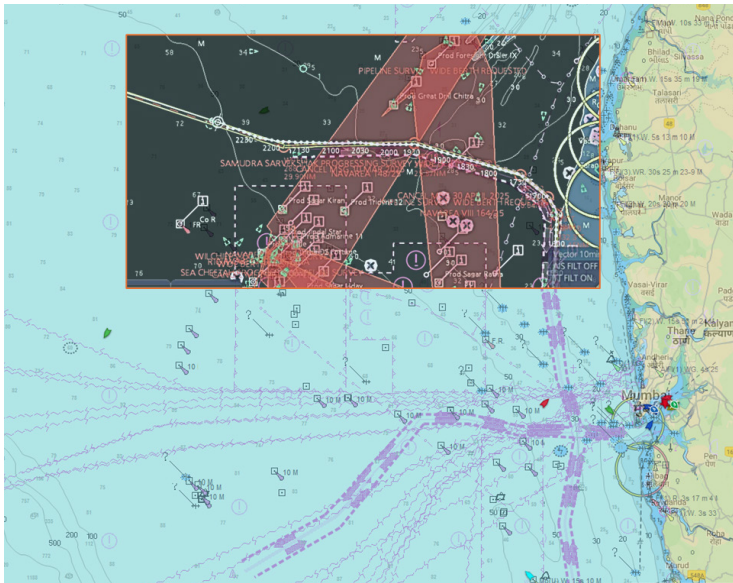
Figure 2: At 2200 JABAL HAFIT exited the TSS as indicated from positions plotted every 30 minutes and captured on ECDIS screenshot (inset).

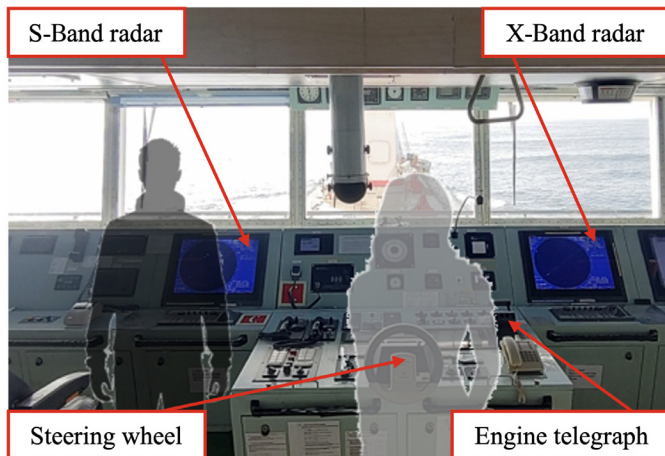
Figure 3: Positions of the J3/O (black) and 3/O (grey) on the Bridge.

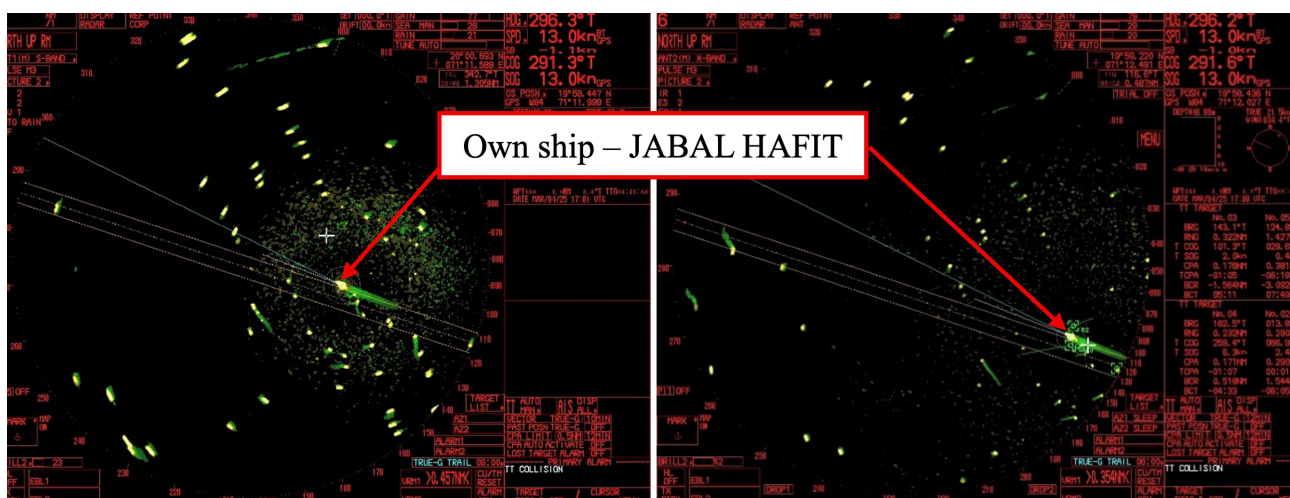
The J3/O was the Lookout during the 3/O’s navigation watchkeeping duties. During the J3/O’s Lookout duty, the radar’s ARPA was used to acquire and monitor vessels and the J3/O apprised the 3/O of the vessel’s ARPA data. Both radars were set at north-up, relative motion with own ship positioned off-center to the bottom right of the radar screen (see Figure 4).

Figure 4: Screenshot of S-Band radar on the right and X-Band radar on the left, both radars were set to 6 NM range scale with the own ship positioned off-center to the bottom right of the radar screen.

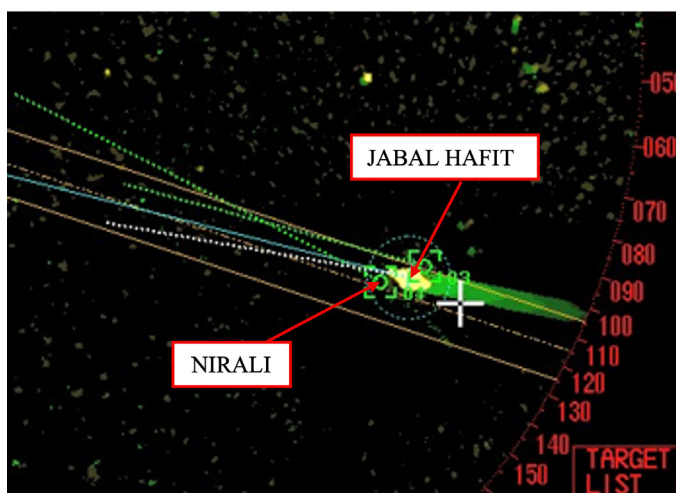
Figure 7: At 2246 NIRALI was forward of JABAL HAFIT, close to the port bow.

Due to the proximity of both vessels, it could not be observed on the radar if NIRALI had maneuvered following the use of the daylight signaling lamp. No sound signals were given as an additional attempt to attract attention.<sup>24</sup>
