SASEBO ECO MARINE SAFETY INVESTIGATION REPORT

Occupational Fatality

Malacca Strait | 11 May 2023

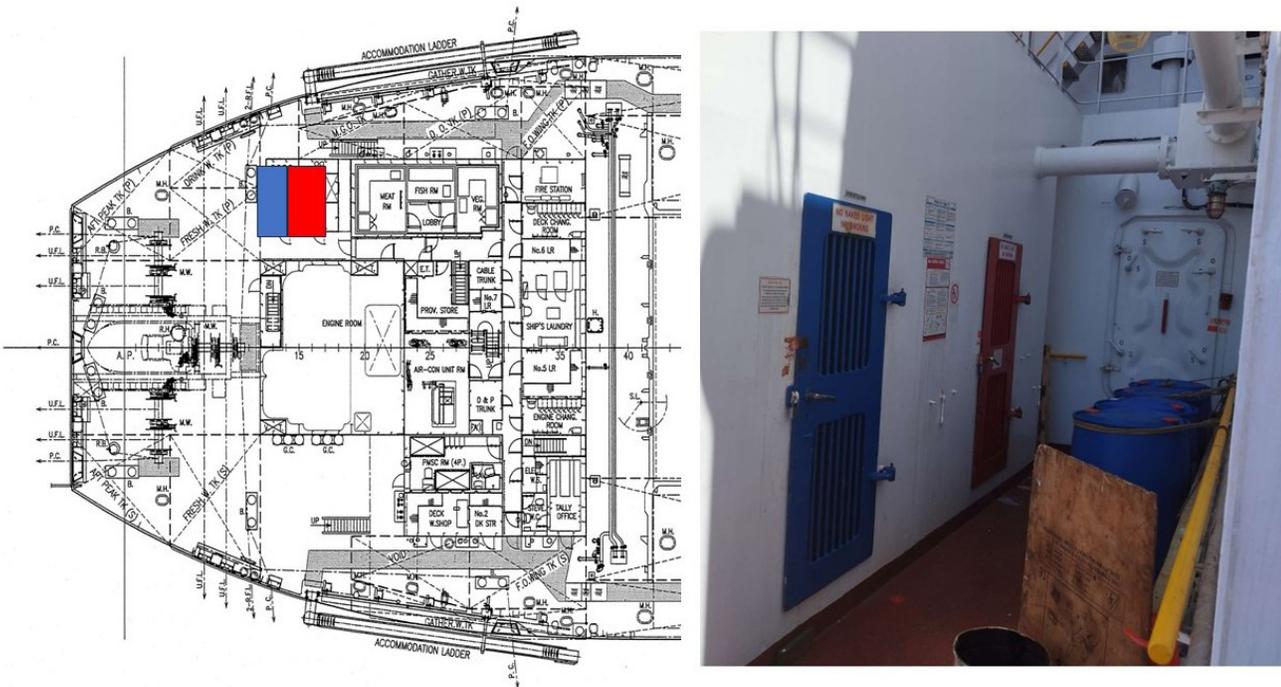
Figure 2: Location of the Oxygen Bottle Room (in blue) and Acetylene Bottle Room (in red). Both were accessible from the Poop Deck. The door leading to the Engine Room is to the right of the weather tight door at the end of the alley way.

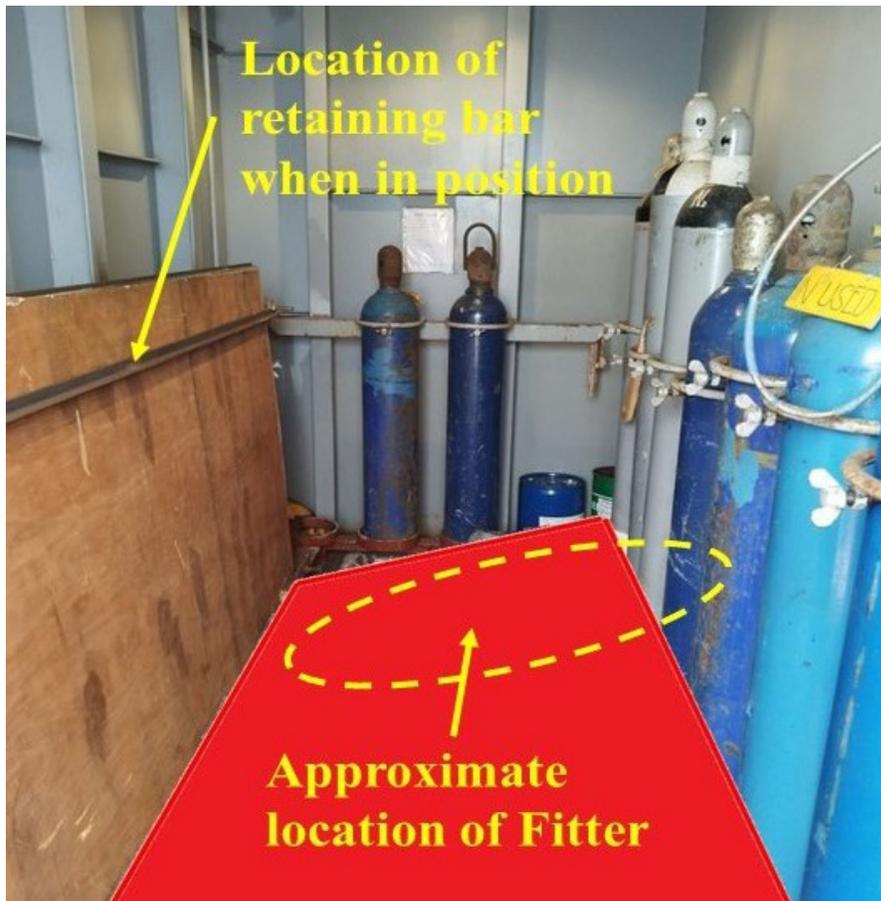
At 1115, the C/E, who was making his routine daily round of the ship, observed that the door to the Oxygen Bottle Room was open. He looked inside and saw steel plates lying on the Fitter's body in such a way that only his head could be seen. The Fitter's body was wedged in a semi-reclined position with the steel plates lying on top of his legs and chest, the back of his legs and back on the deck, and his head pressed against two of the oxygen bottles (see Figure 3). The retaining bar² was at the edge of the steel plates pressed against the Fitter's neck.

Figure 3: The approximate position of the steel plates and location of the Fitter when he was found by the C/E. The picture was taken from the door leading into the Oxygen Bottle Room.

When found by the C/E at 1115, the Fitter was facing the storage rack pinned in a semi-reclined position by the steel plates, which were lying on his legs and chest. Only his head, which was pressed against two of the oxygen bottles, was visible (*see Figure 3*). The retaining bar was along the edge of the steel plates and was pressed against the Fitter's neck. It is not known how long the Fitter had been in the Oxygen Bottle Room before he was found by the C/E or what he had been doing before the steel plates fell and likely knocked him down.

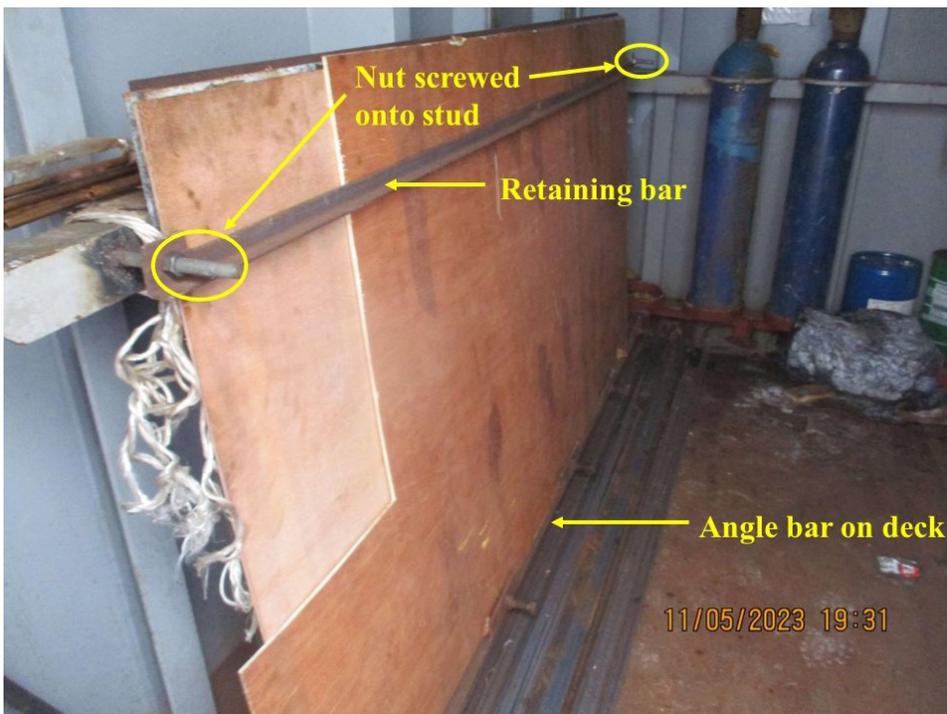
The steel plates were stored in a vertical rack located on the aft bulkhead in the Oxygen Bottle Room, which was oriented athwartship. A thin sheet of plywood was between each of the steel plates. The storage rack consisted of a steel angle bar welded to the deck and a retaining bar that was secured by tightening nuts on studs that were welded to a horizontal stiffener (see Figure 4). These nuts would have been required to be unscrewed all the way so that the retaining bar could be removed when handling steel plates.³

Figure 4: Steel plate stowage rack inside the Oxygen Bottle Room. There were loose pieces of steel angle bar lying on the deck next to the steel plate storage rack.

The retaining bar was supposed to be removed only when steel plates were being handled. The steel plates were leaning at a slight angle against the aft bulkhead of the Oxygen Bottle Room. There was no evidence that the retaining bar had not been put back in place after it had last been removed or that it had not been properly secured. There is also no evidence that any crewmember other than the Fitter had been in the Oxygen Bottle Room on the morning of 11 May 2023.

The location and design of the storage rack was effective for storing steel plates securely. However, a hazard inherent with the design was that there was always the potential for the steel plates to fall whenever the retaining bar was removed or failed for any reason. An additional hazard inherent with the location of the storage rack was that it was necessary

The steel plates that were lying on the Fitter each weighed 294 kg and had fallen from the storage rack located inside the Oxygen Bottle Room. Although it is not known what caused the plates to fall, they would not have been able to fall if the retaining bar was in place and properly secured. The fact that the steel plates fell indicates that the retaining bar had either:

- (a) not been put back in place after it was last removed;
- (b) been put back in place but had not been properly secured;
- (c) been put back in place but the system of securing the bar had failed; or
- (d) been removed by the Fitter.

If the retaining bar had not been put back in place after it was last removed, it would likely have been left lying on either the deck adjacent to the base of the storage rack or the horizontal stiffener that the studs were welded to (*see Figure 4*). If the retaining bar had been in either of these locations when the steel plates fell, it is unlikely that it would have been found pressed against the Fitter's neck. Rather, it would have been lying under the steel plates on the deck near the Fitter's feet or lying loose on either the horizontal stiffener or on top the steel plates. If the retaining bar had not been put back in place after it was last removed, the steel plates would most likely have fallen previously. Further, either the C/E, while making his daily round of the ship,⁷ or the Fitter, when he had gone to the Oxygen Bottle Room to open or close the main control valve for the oxygen supply line either on 11 May 2023 or sometime previously, would likely have noticed that the retaining bar was not in position and taken action to secure it.

There is the possibility that the retaining bar had not been put back in place after it was last removed, and that the Fitter had been in the process of putting it in place when the steel plates fell. If the Fitter had been putting the retaining bar back in place, the retaining bar would most likely have been found underneath the steel plates pressed against his chest rather than at the edge of the plates pressed against his neck. It was not determined if the rope seen in *Figure 4* had been used to secure the steel plates.

1. That racks for storing steel plates on all Company-managed ships be configured so that:
 - (a) there are mechanical means of preventing steel plates from falling when handled; and
 - (b) to facilitate the ergonomic handling of steel plates.
