AZOV CONFIDENCE MARINE SAFETY INVESTIGATION REPORT

Fatal Engine Room Casing Fire

Black Sea | 2 November 2022

IMO Number: 9372602

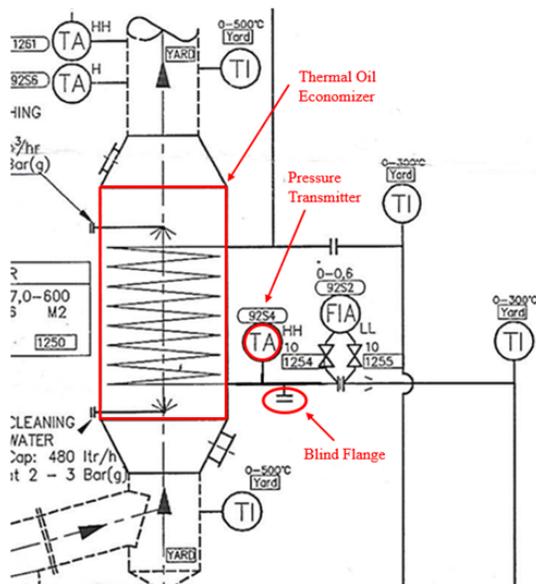
Figure 3: Thermal Oil System schematic.

The closed loop system uses centrifugal pumps to circulate the MGO and HFO from the settling tank to the Economizers and return the heated thermal oil to the fuel pumps. The thermal oil system (see Figure 3) operates between 1-6 bar³ and after passing through the Economizer has a temperature of approximately 180°C. The body of the Economizer is provided with incombustible insulation, which is protected by a galvanized steel jacket. A thermal survey used to identify any gaps in the thermal insulation of the Economizer had not been undertaken by the Company on either the port or starboard Economizers.
